# Fracture Behavior of Nickel-Based Single Crystal Superalloy During High-Cycle Fatigue at 850 °C

**Abstract:** The high-cycle fatigue fracture characteristics and damage mechanism of nickel-based single crystal superalloys at 850 °C was investigated. The results indicate that high-cycle fatigue cracks in single crystal superalloys generally originate from defect locations on the subsurface or interior of the specimen at 850 °C. Under the condition of stress ratio  $R=0.05$ , as the fatigue load decreases, the high-cycle fatigue life gradually increases. The high-cycle fatigue fracture is mainly characterized by octahedral slip mechanism. At high stress and low lifespan, the fracture exhibits single or multiple slip surface features. Some fractures originate along a vertical small plane and then propagate along the  $\{111\}$  slip surface. At low stress and high lifespan, the fracture surface tend to alternate and expand along multiple slip planes after originating from subsurface or internal sources, exhibiting characteristics of multiple slip planes. Through electron backscatter diffraction and transmission electron microscope analysis, there is obvious oxidation behavior on th

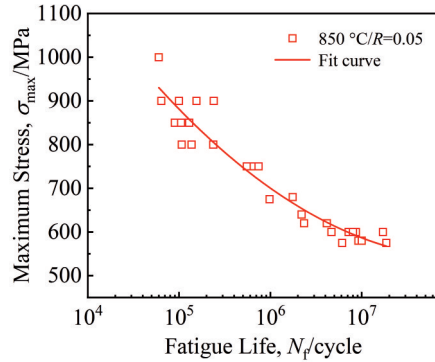
Fig.2 High-cycle fatigue performance of single crystal superalloy at 850 °C

The relationship between the maximum loading stress  $\sigma_{\max}$  and the fatigue life  $N_f$  under the condition of 850 °C and stress ratio of  $R=0.05$  is shown in Fig. 2. When  $\sigma_{\max}$  is between

800–1000 MPa, the high-cycle fatigue life of the single crystal alloy is approximately  $10^5$  cycles. As the applied load decreases, the high-cycle fatigue life gradually increases. When  $\sigma_{\max}$  is 575 MPa, the high-cycle fatigue life of the alloy reaches around  $10^7$  cycles.

1) Under the condition of 850 °C and stress ratio  $R=0.05$ , as the fatigue load decreases, the high-cycle fatigue life gradually increases. Under this condition, the fatigue limit of single crystal superalloy is about 575 MPa.

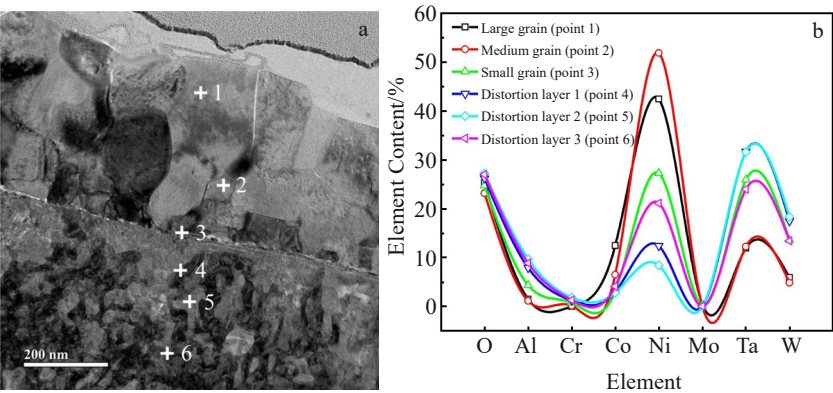
Fig.10 TEM image of oxidation layer and distortion layer on fracture surface (a) and variation curves of element content at different points marked in Fig.10a (b)

Local element content analysis was conducted on six different points within the oxidation layer and distortion layer on the fracture surface. The analysis points are shown in Fig. 10, with large grains, medium grains, small grains, and distortion layer at different depths from the surface inward. The large grains in the outer layer of the oxidation layer and the grains in the inner layer are mainly composed of elements O, Co, Ni, as well as a small amount of elements Ta and W. The outermost layer has a slightly higher Co

content. For small grains at the boundary between the oxidation layer and the distortion layer, the content of elements Co and Ni decreases significantly compared to the outer grains, while the content of elements Ta and W increases, and the content of element Al slightly increases. The content of elements Al, Cr, Ta, and W in the distortion layer is significantly increased, while the content of elements Ni and Co is decreased. The specific element content of

Table 2 Element content at different points marked in Fig.10a (wt%)
